Marian MARSCHALKO¹, Libuše HOFRICHTEROVÁ², Lubomír TŘESLÍN

**ENGINEERING-GEOLOGICAL CONDITIONS OF LANDSLIDE IN THE OSTRAVA-KARVINÁ
COALFIELD**

The paper deals with a slope deformation Staříč (sequence number 2) in the Frýdek Místek district in the north-east of the Czech Republic. It makes part of a wider three-year study, which comprises 6 localities of slope movements in total (sequence numbers 1 to 6) in the Ostrava-Karviná District, in case of which there is a potential precondition for changes in stability due to undermining. In the first phase, archive materials, basic data, aerial photographs of slope deformation were studied and evaluated. Subsequently, engineering-geological mapping were performed, on the basis of which all landslide manifestations, such as starting scar, cracks, layer outcrops, hydrogeological structures etc. were recorded. After this phase, resistivity tomography measurements (geophysical method of multielectrode resistivity measurement) were taken. The mentioned methodology was applied in the interest area for the first time.

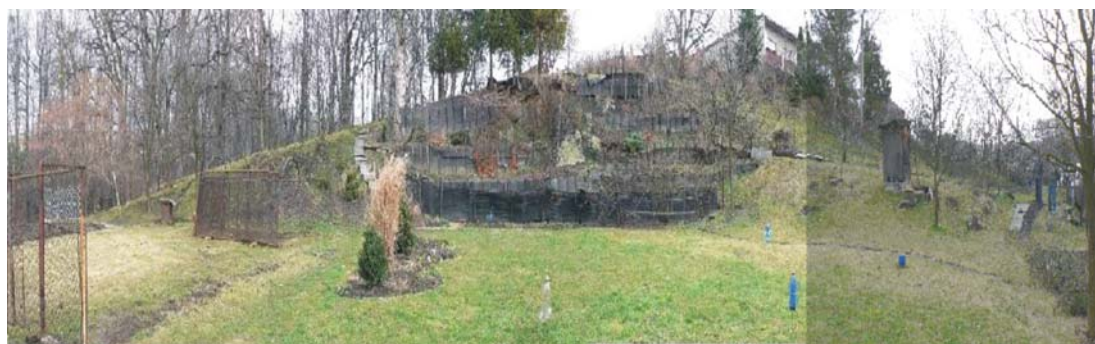
The tear edge of the slide is pronounced, it reaches as high as 7 m (Figure 4) and spreads in the direction NW-SE.

**Fig. 4:** Tear edge of the slide

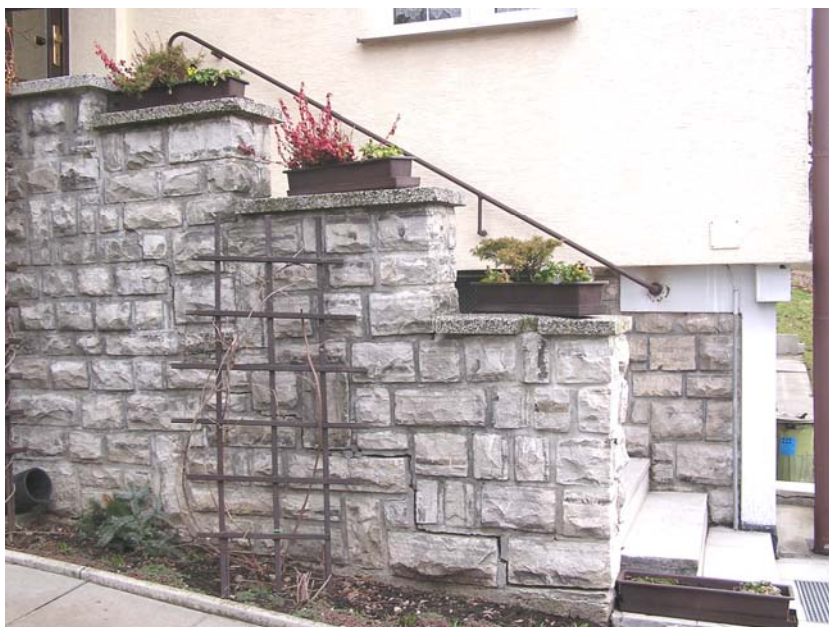
As for the circumstantial evidence of the slope deformation and its active manifestation, we identified damage to the construction of the house (Figure 5), to the workshop (Figure 6), bending of trees in its vicinity (Figure 7), sliding and displacement of the top soil near the workshop (Figure 8), bent fence in the top part of the slope deformation (Figure 9), and terrain deformation with the manifestation of floor bulging in the workshop up to 15 cm (Figure 10).

Fig. 5: Damage to the construction of the house

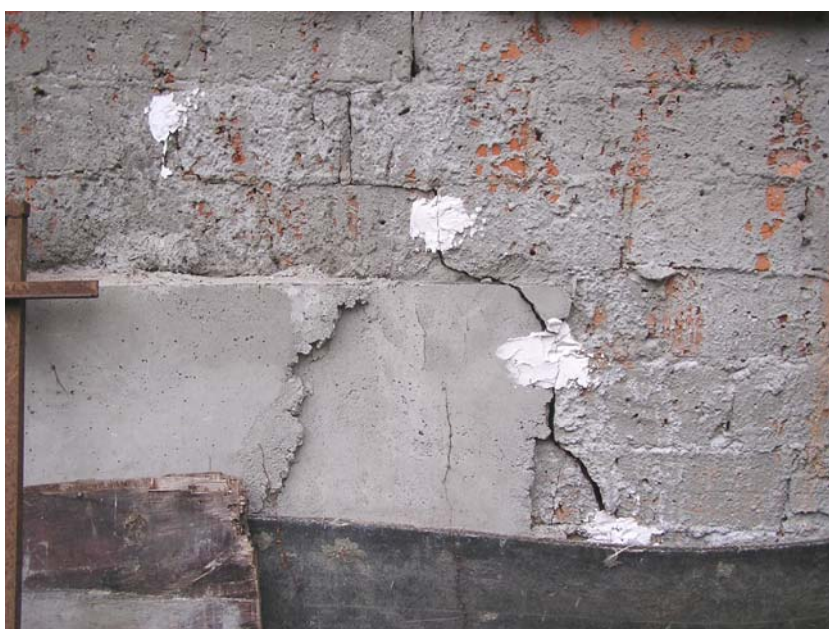
Fig. 6: Damage to the construction of the workshop

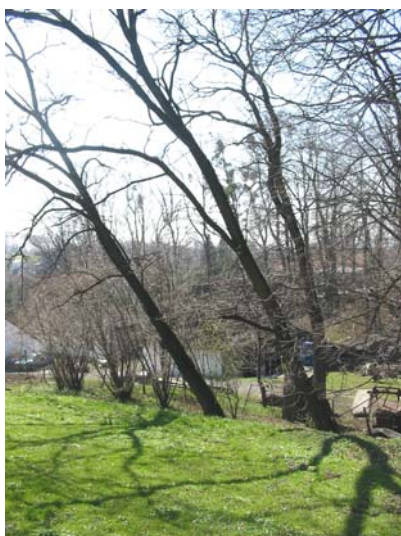
Fig. 7: Bending of trees

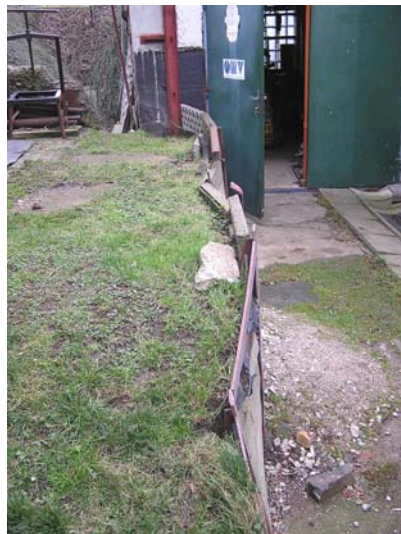
Fig. 8: Sliding and displacement of the top soil near the workshop

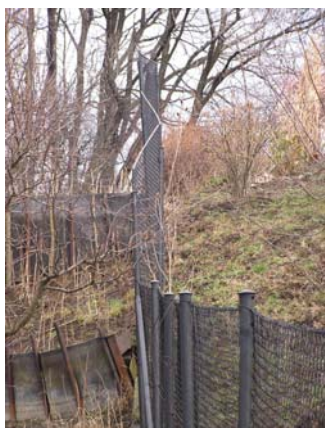
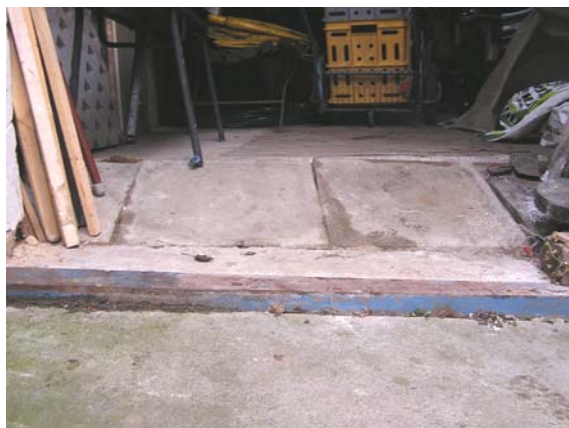
Fig. 9: Bent fence in the top part of the slope deformation (left) Figure 10 Terrain deformation with the manifestation of floor bulging in the workshop up to 15 cm (right)

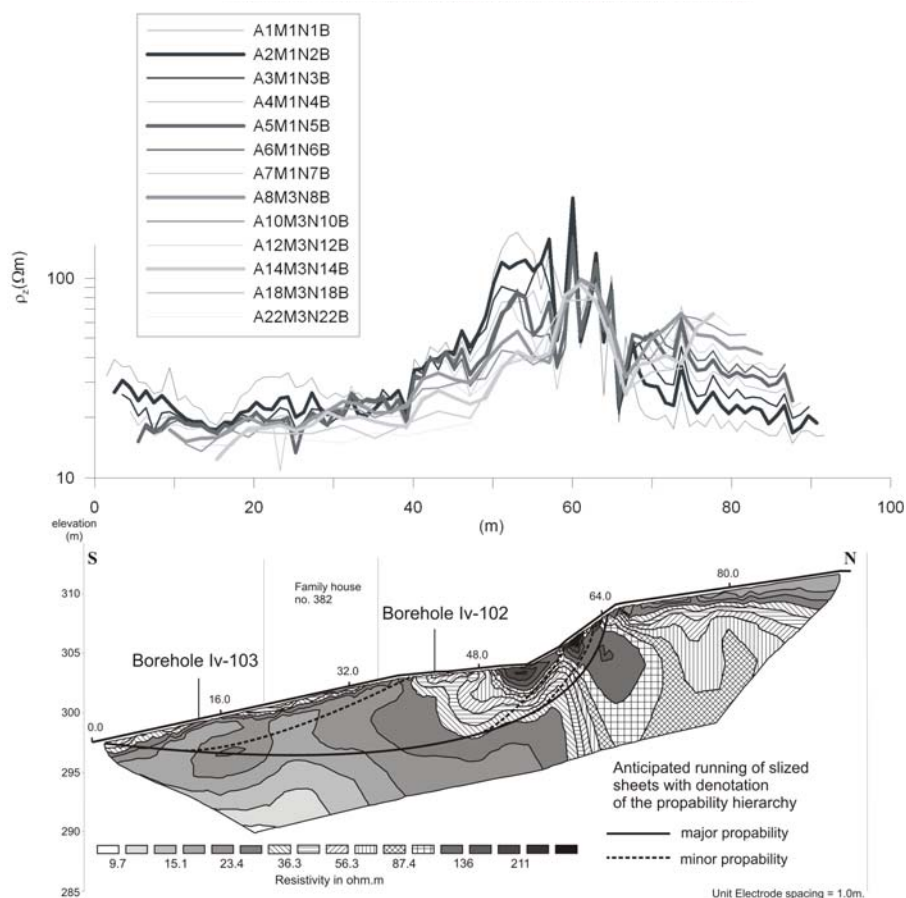
Fig. 11: Resistive model of S1 section

The interpretation of the slip surfaces of *S1 section* (Figure 11) was mainly conditioned by morphology, by means of top tear edge manifestation, and next by inclinometric measuring in the bores Iv-102 and Iv-103 (bore placement – Figure 3). According to the inclinometric measuring in the bore Iv-102 an occurrence of a slip surface was proved in the approximate depth of 6-7m under the collar of well and the slip surface depth identified in the bore Iv-103 was about 3 m p. t. (under the ground). Inclinometric measurements register both movements caused by undermining in the direction of the subsidence trough as well as movements related to a slide.

Resistively, the outcrop of tessenites is demonstrated by a considerable rise in resistance, 150 Ω m and more, and the course of the slip surface is situated between the maximum resistance values on the stationing 50 - 65 m and next, it runs in an inclinometrically identified depth in the bore Iv-102. Cracks were situated according to local resistive minimums both in the model as well as in the section curves.

As for lithology, the tear edge begins at the outcrop of tessenites on the stationing 65m and transits to silty claystone (it is identified in the place of bore Iv-102 2.5 m under its roof).

With the bore IV-103 in the slip surface depth there is a boundary between clayey-sandy loam and loamy-stony debris in the bedrock.

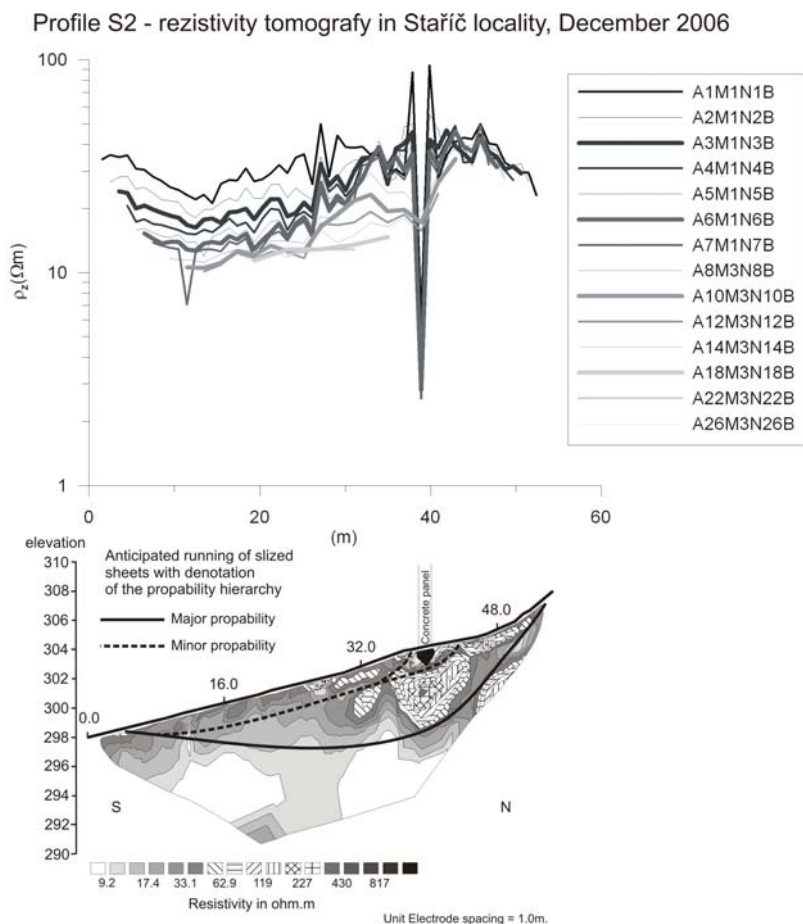
Fig. 12: Resistive model of S2 section

The determination of the course of the slip surface with *S2 section* (Figure 12) was only grounded in the areal continuity of the course of the slip surface as in the vicinity of the measured section there is no inclinometric bore. Similarly to the S1 section, this slip surface is affected by morphology and its course is situated between the local maximums of impedance. The maximum depth of the estimated slip surface 6 m p.t. is found on the stationing 37m.
